Case Study: SUPERMARKET APPLICATION

Supermarket Sees Overall Energy Savings, Solutions to Problems of Sweating Doors, Hot/Cold Areas, Severe Energy Loss, Customer Safety

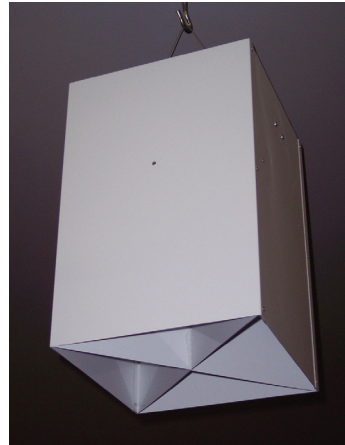
Air-Row F-18
For Open Ceilings

- Air-Row F-18 fans reduced the burn time on the natural gas heating and cooling units by 40-50%.
- Thermostats in the store were reset 3-5 degrees lower.
- Supermarket realized 9-15% energy savings.

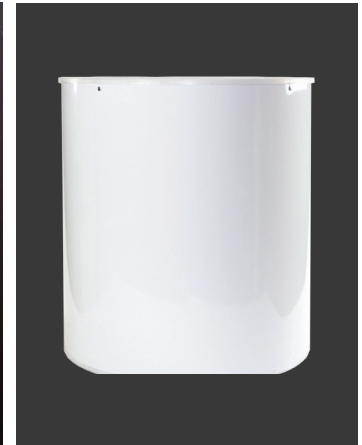
Air-Row F-18R (round)
For Open Ceilings
